Kentucky Creek Dam

Dam Safety Emergency Plan

Uralla Shire Council

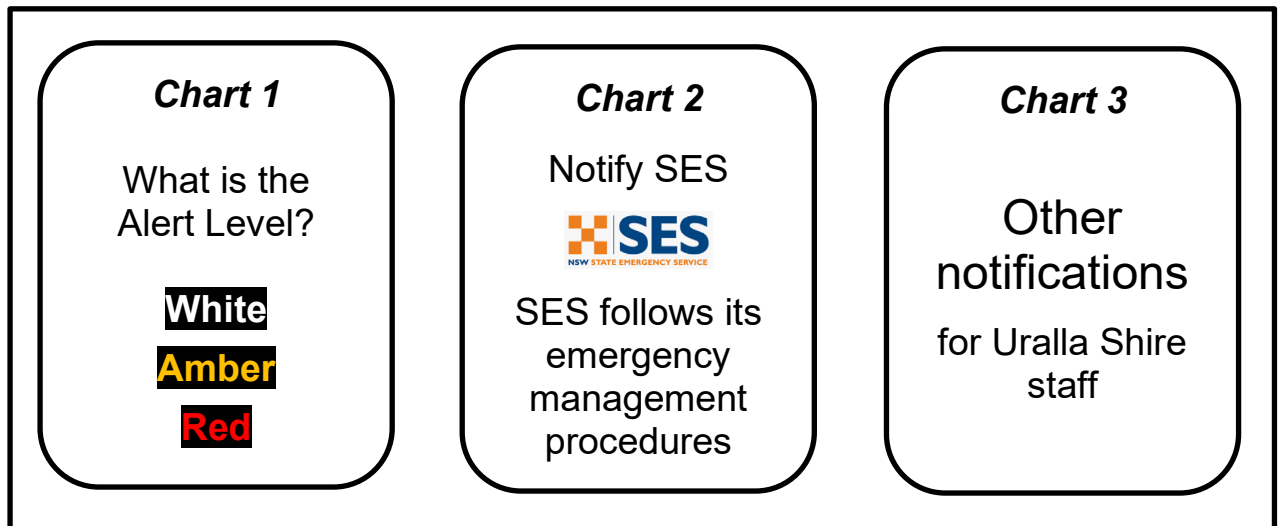
Figure 1 Emergency management process, Kentucky Creek Dam

Three flow charts (Charts 1 – 3) are included at the beginning of this document. They illustrate the flow of information and decision making to be followed in an emergency (Figure 1). They summarise the decisions to be made, personnel to be notified, and the prioritised order of notification in an emergency.

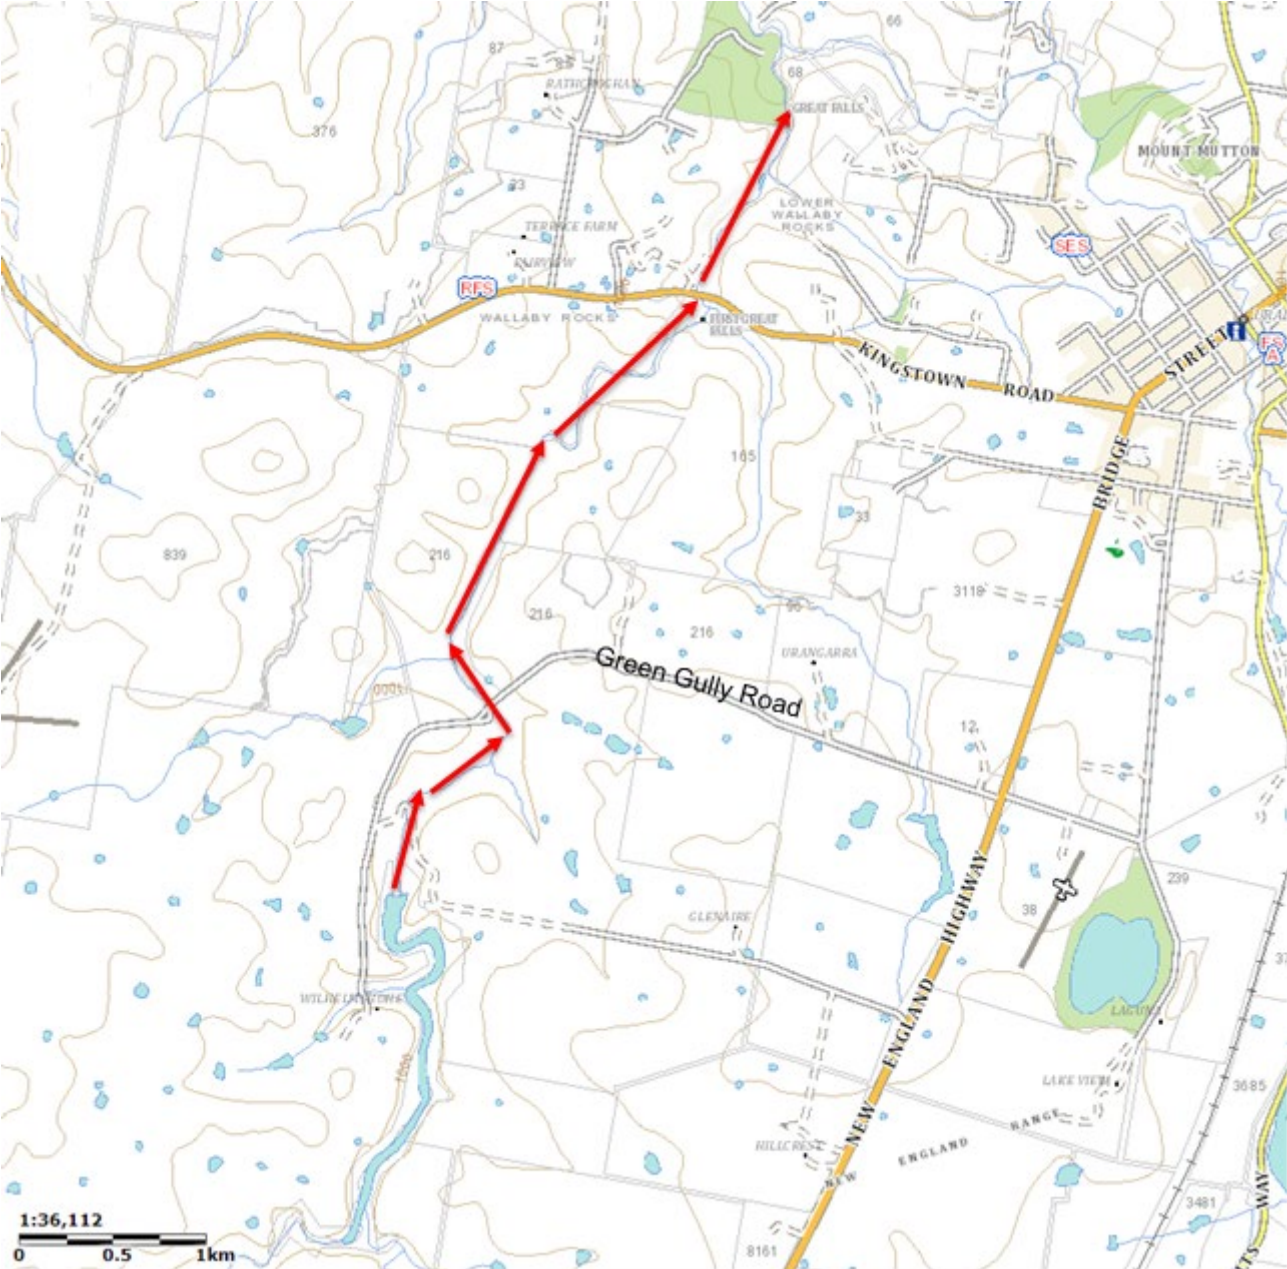
Dambreak Inundation Plan

A dambreak study or inundation mapping has not been undertaken for Kentucky Creek Dam
Figure shows the direction of floodwater travelling downstream.
